September 14, 2015
Rincon Project No. 15-01938

Subject: Jurisdictional Waters Evaluation Technical Memorandum for the Scotts Valley 2 Project, Scotts Valley, Santa Cruz County, California

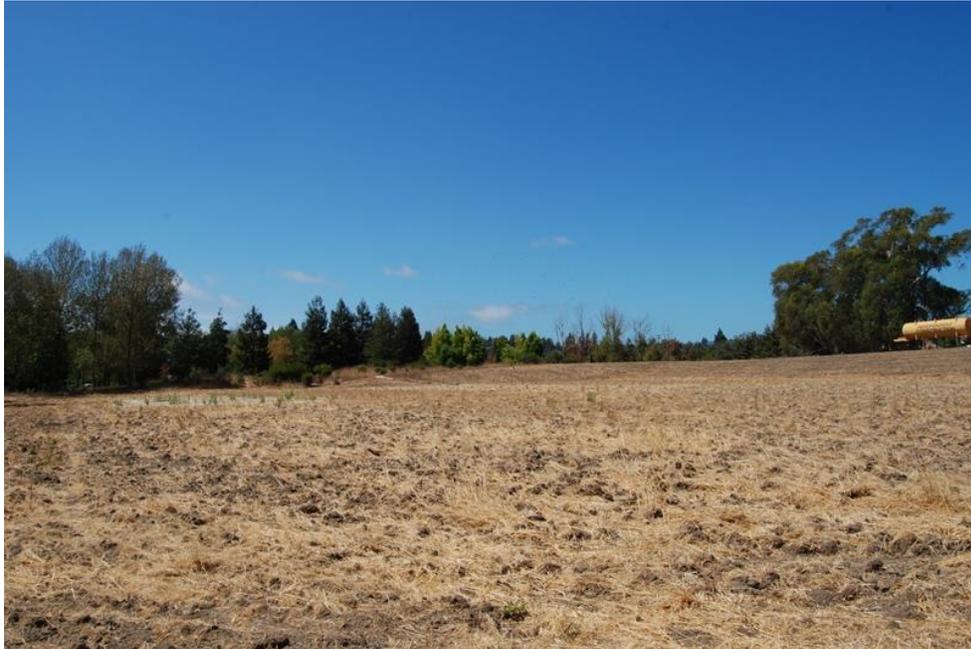
Photo 1. Non-native annual grassland on the project site.

Site conditions were confirmed during the reconnaissance survey. The site consists predominantly of non-native annual grassland (see Photo 1 in Attachment) dominated by wild oats (*Avena* sp.), with other non-native and invasive herbaceous species. A large berm has been established along the northern edge of the site adjacent to Santas Village Road (see Photo 2 in attachment). At the base of the berm the site becomes a flat field that slopes almost imperceptibly south toward Carbonara Creek. The site has been recently disked and there was no sign of recent or historical ponding or accumulation of water in any part of the site. A very small artificial basin was constructed as part of a sewer system, probably in the early 1990s. A sewer drain is still present at this location (see Photo 3 in attachment); however there is no sign of wetland habitat ever having formed in this basin. The site is highly disturbed and consists in large part of artificial fill material at the surface (see Photo 4 in Attachment). The historical aerial imagery indicates that the site was at one time under construction as part of the adjacent sports complex development.

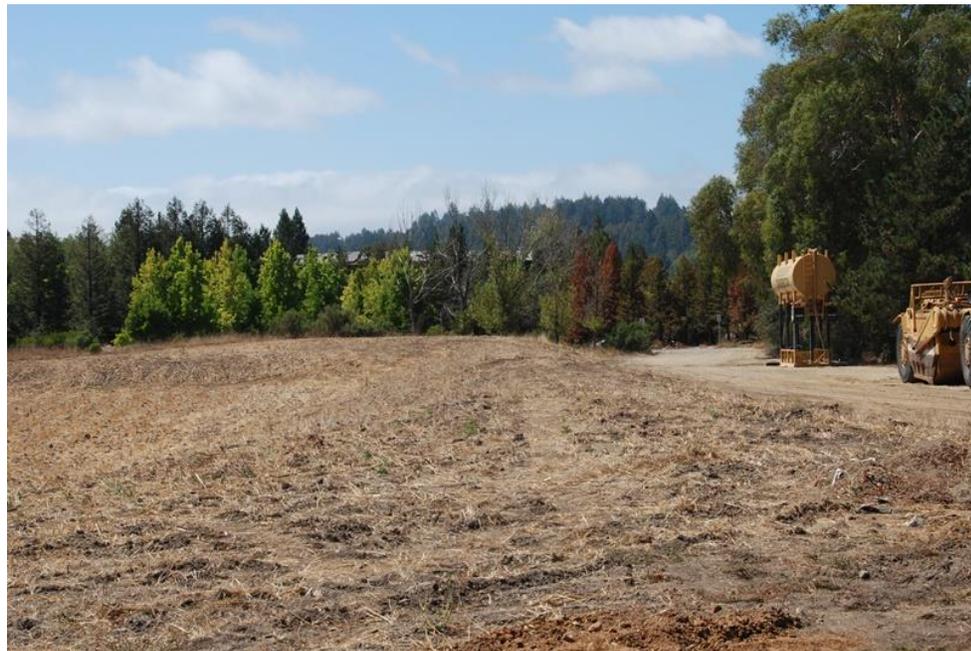
Photo 2. The site has an artificial berm constructed along the northern boundary. Santas Village Road is on the right.

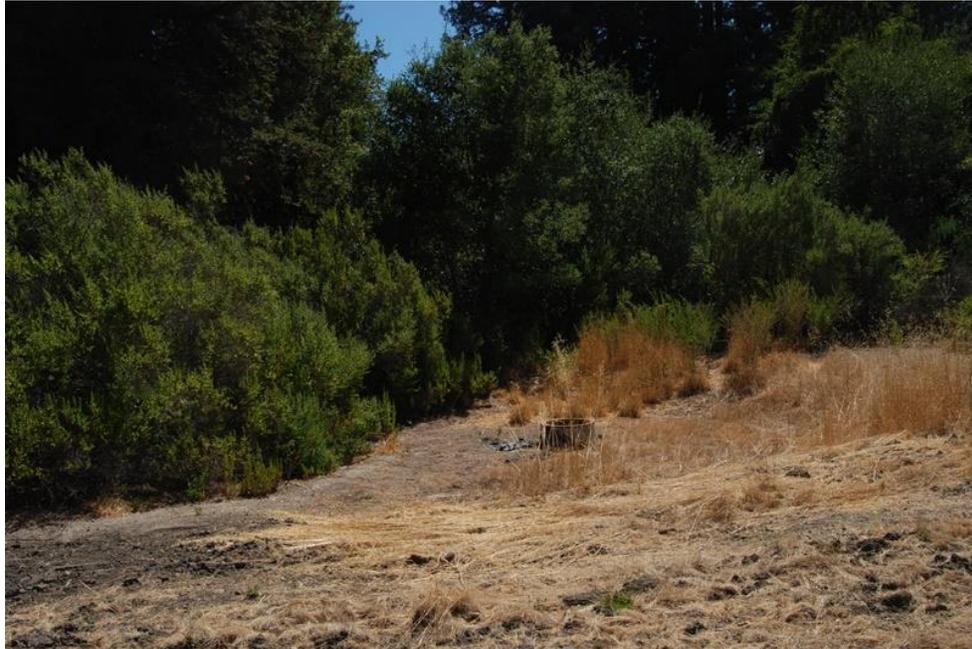
Photo 3. A drain and associated sewer construction is present adjacent to Carbonara Creek on the south side of the project site.

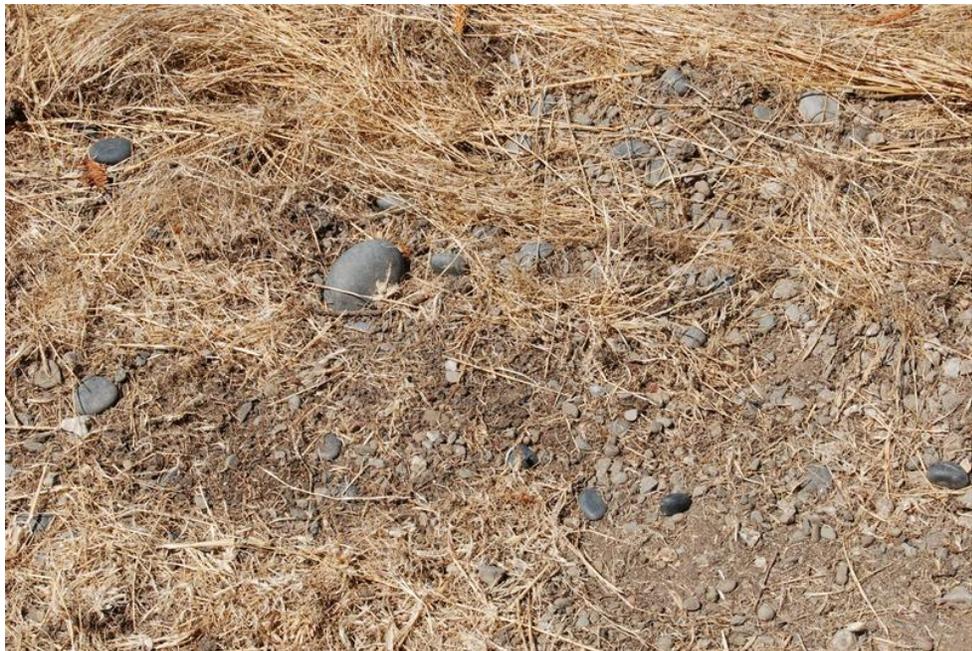
Photo 4. Artificial fill covers the majority of the project site outside of Carbonara Creek.
